**Flood Control Project Maintenance
Levee Inspections**

2018 Channel Summary Report

San Joaquin County Flood Control and Water Conservation District

Flood Control Project Maintenance**Unit Cover Sheet****2018 Channel Inspection Results****San Joaquin County Flood Control and Water Conservation District**

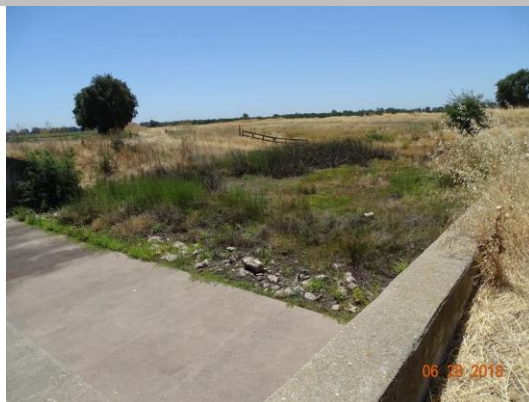
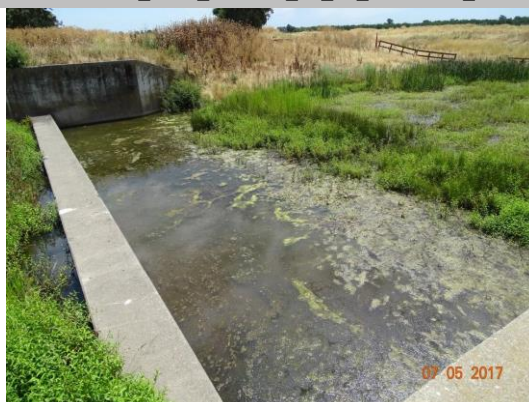
Photo 1 of 2 : CH_2018_NA0017_43_31_20180702_00013.jpg

Inspector Comments: Minimal vegetation in the channel should not impede the flow.

View of the vegetation in the diversion channel looking downstream during 2018 inspection.

View of the vegetation in the diversion channel looking downstream during 2017 inspection.

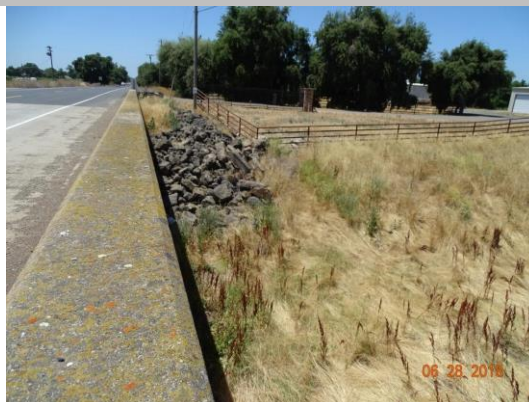
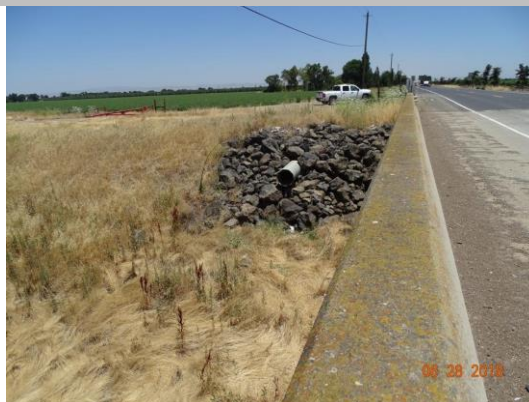
Photo 1 of 2 : CH_2018_NA0017_43_14_20180702_00015.jpg

Inspector Comments: Existing riprap appears to be properly maintained.

View of the revetments on the right bank of the channel looking upstream, 2018

View of the revetments on the left bank of the channel looking upstream, 2018.

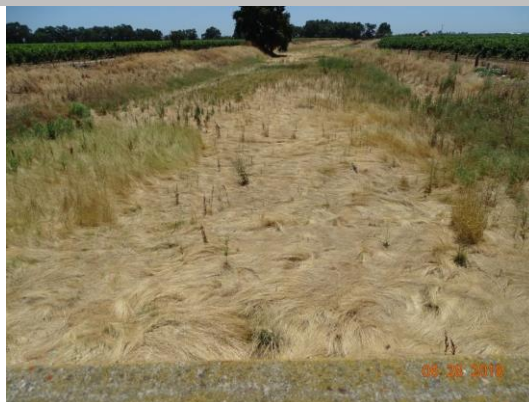
Photo 1 of 1 : CH_2018_NA0017_43_16_20180702_00018.jpg

Inspector Comments: Minimal vegetation is present in the channel but it doesn't appear to obstruct the flow of the channel.

View of the vegetation looking downstream of the channel. Summer 2018

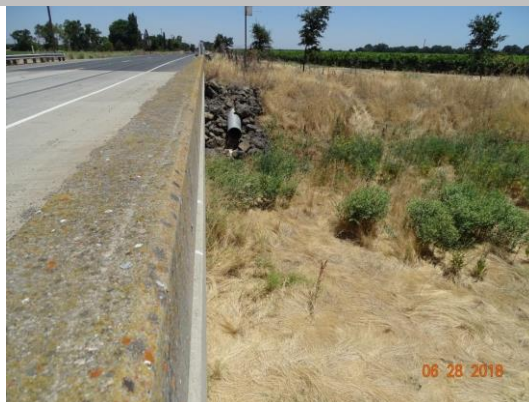
Photo 2 of 2 : CH_2018_NA0017_43_19_20180702_00019.jpg

View of the revetments on the left bank of the channel looking downstream, 2018.

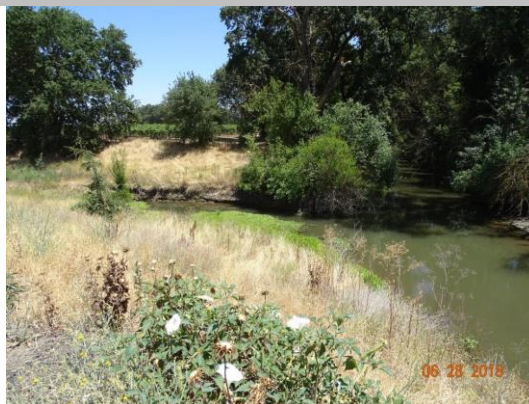
Photo 1 of 1 : CH_2018_NA0017_43_21_20180702_00021.jpg

Rating **	A	Issue No.	21	GPS Lat/Long
Issue Type +	Ma	Location *		37.925730 °
Category	Rivers, Channels & Designated Flood			-120.992290 °
Item	Vegetation & Obstructions			
DWR ID	DWR_NA0017_43_c_2012_21			
Action/Comments				
Inspector Comments: Vegetation growth in the channel does not appear to impede the flow.

View of the confluence during 2018 inspection.

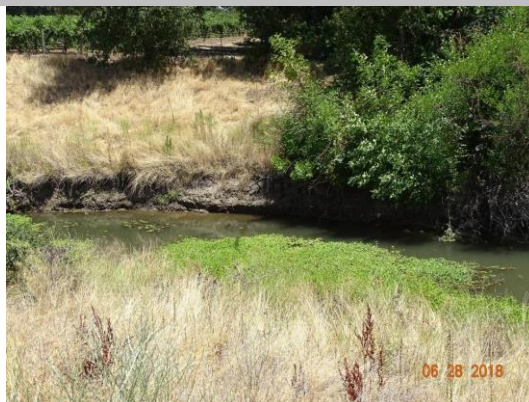
Photo 1 of 1 : CH_2018_NA0017_43_23_20180702_00022.jpg

Inspector Comments: Minimal erosion was present during inspection but does not appear to impact the capacity of the channel.

Minimal erosion on left bank of channel at confluence, 2018

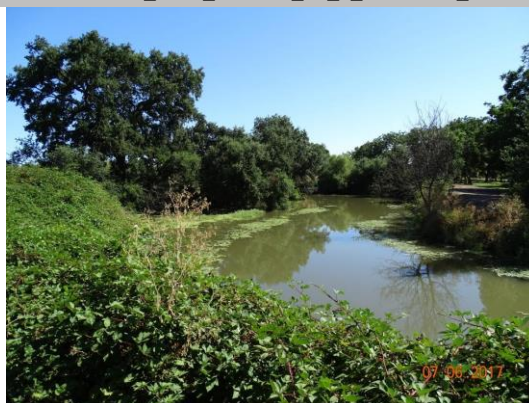
Photo 2 of 2 : CH_2018_NA0017_42_6_20180530_00001.jpg

Inspector Comments: Minimal vegetation was found, but they do not obstruct the flow of the channel.

View of the vegetation on the upstream of the channel.

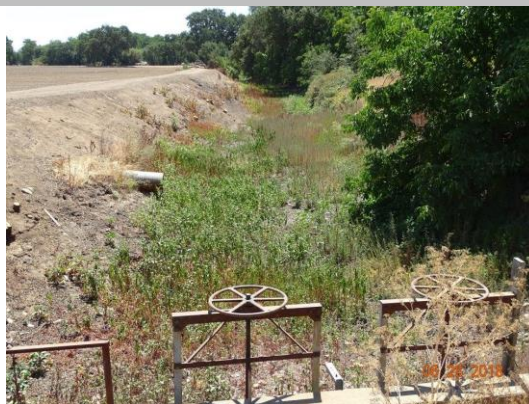
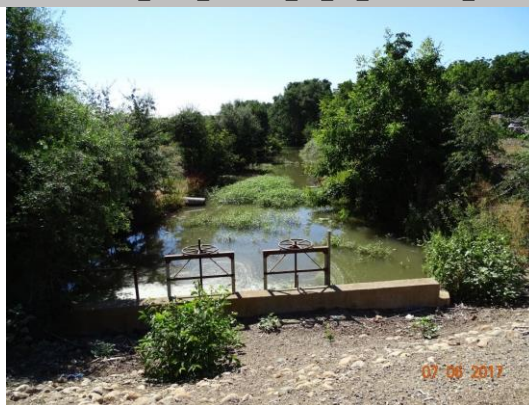
Photo 1 of 2 : CH_2018_NA0017_42_11_20180702_00073.jpg

Inspector Comments: Minimal vegetation exist, but it will not impede the flow of the channel.

View of the channel looking upstream during 2018 inspection.

View of the channel looking upstream during 2017 inspection.

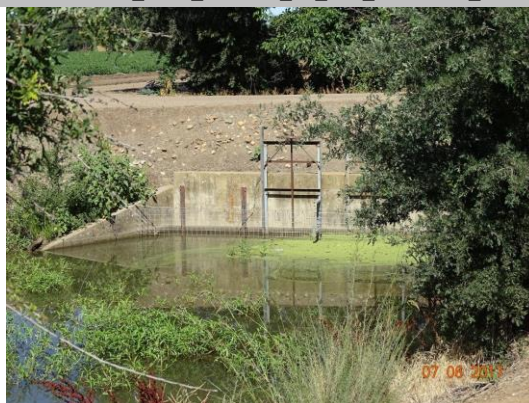
Photo 2 of 2 : CH_2018_NA0017_42_113_20180530_00050.jpg

Inspector Comments: Slide gates appeared to be in good operational condition.

View of the slide gate on the upstream of the channel.

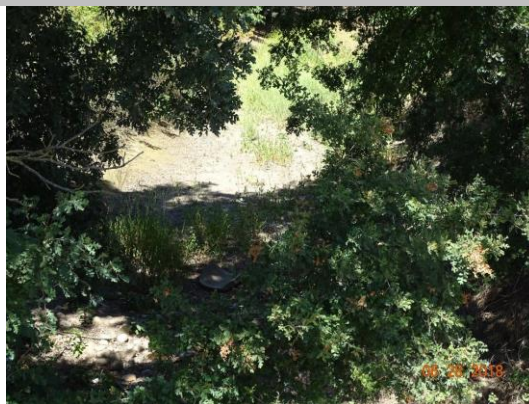
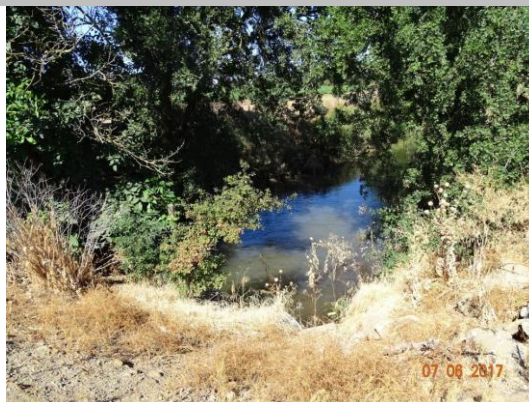
Photo 1 of 2 : CH_2018_NA0017_42_16_20180702_00074.jpg

Rating **	A	Issue No.	16	GPS Lat/Long
Issue Type +	Ma	Location *		37.920584 °
Category	Rivers, Channels & Designated Flood			-121.037914 °
Item	Vegetation & Obstructions			
DWR ID	DWR_NA0017_42_c_2012_16			
Action/Comments				
Inspector Comments: Walnut tree exists on left side of the shoulder. It does not obstruct the flow, but it could fall down in the creek.

View of the vegetation on the channel looking downstream during 2018 inspection.

View of the vegetation on the channel looking downstream during 2017 inspection.

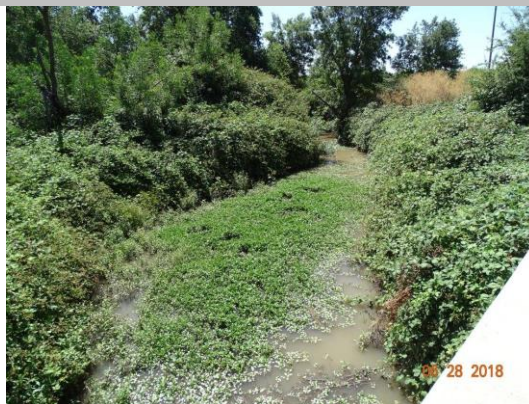
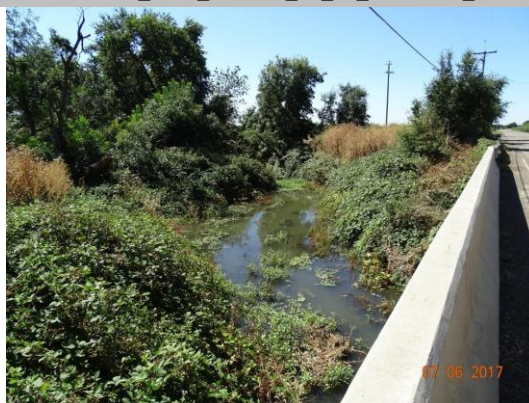
Photo 1 of 2 : CH_2018_NA0017_42_21_20180702_00070.jpg

Inspector Comments: Vegetation growth on the slopes need to be removed. Flow is likely not impeded.

View of the vegetation on the channel looking upstream. Summer 2018

View of the vegetation on the channel looking upstream. Summer 2017

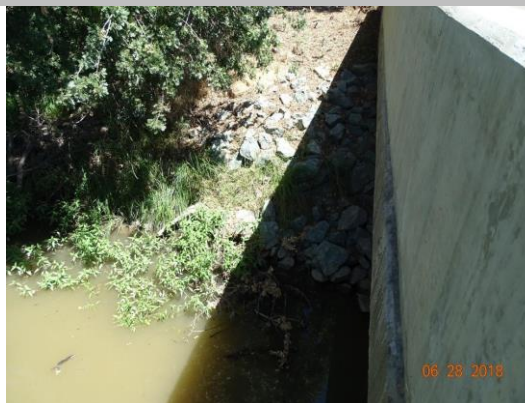
Photo 1 of 1 : CH_2018_NA0017_42_29_20180702_00072.jpg

Inspector Comments: Existing revetments appear to be properly maintained.

View of existing revetments on the right bank of the channel looking downstream, 2018.

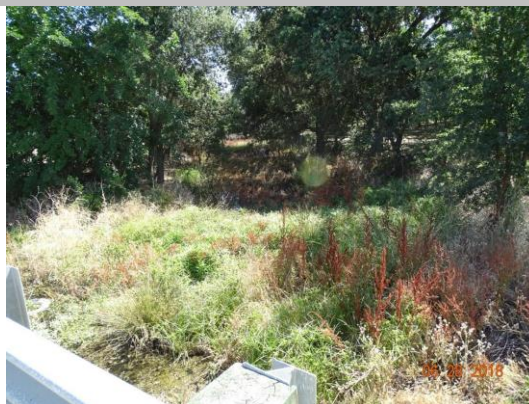
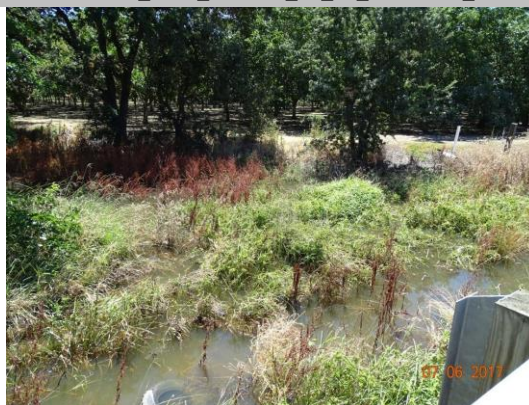
Photo 1 of 2 : CH_2018_NA0017_42_31_20180702_00067.jpg

Inspector Comments: Minimal vegetation exists in the channel, however need to clear woody vegetation in channel.

View of the channel looking upstream during 2018 inspection.

View of the channel looking upstream during 2017 inspection.

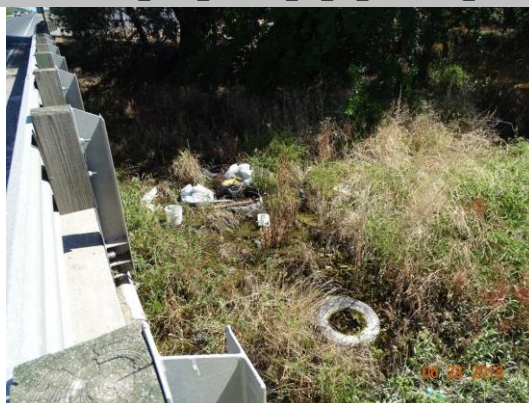
Photo 1 of 1 : CH_2018_NA0017_42_35_20180702_00068.jpg

Inspector Comments: Minimal trash was present on the channel during inspection.

View of the debris in the channel looking upstream during 2018 inspection.

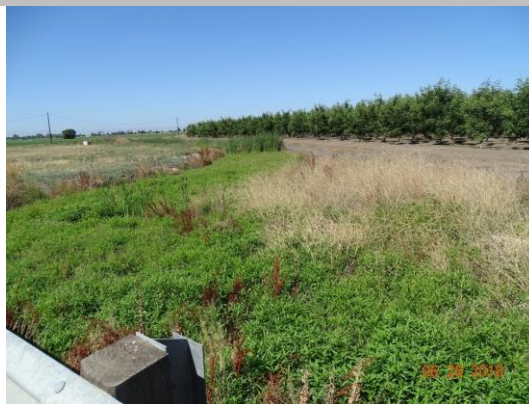
Photo 1 of 1 : CH_2018_NA0017_42_36_20180702_00069.jpg

Rating **	A	Issue No.	36	GPS Lat/Long
Issue Type +	Ma	Location *		37.921460 °
Category	Rivers, Channels & Designated Flood			-121.147570 °
Item	Vegetation & Obstructions			
DWR ID	DWR_NA0017_42_c_2012_36			
Action/Comments				
Inspector Comments: Minimal vegetation on the channel should not obstruct the flow.

View of the channel looking downstream, 2018.

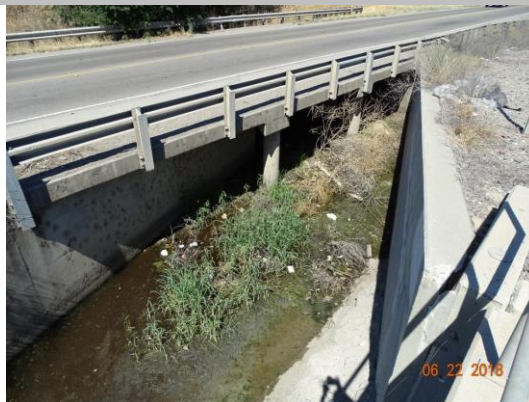
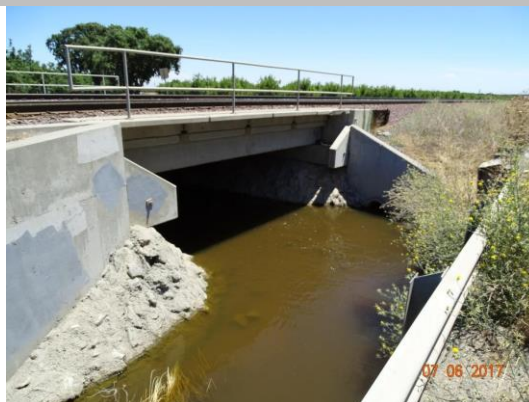
Photo 1 of 2 : CH_2018_NA0017_42_41_20180625_00065.jpg

Inspector Comments: Minimal vegetation on the channel should not impede the flow.

View of upstream of the channel during 2018 inspection.

Rating **	A	Issue No.	41 (cont)	GPS Lat/Long
Issue Type +	Ma	Location *		37.915879 °
Category	Rivers, Channels & Designated Flood			-121.189095 °
Item	Vegetation & Obstructions			
DWR ID	DWR_NA0017_42_c_2012_41			
Action/Comments				
Inspector Comments: Minimal vegetation on the channel should not impede the flow.

View of upstream of the channel during 2017 inspection.

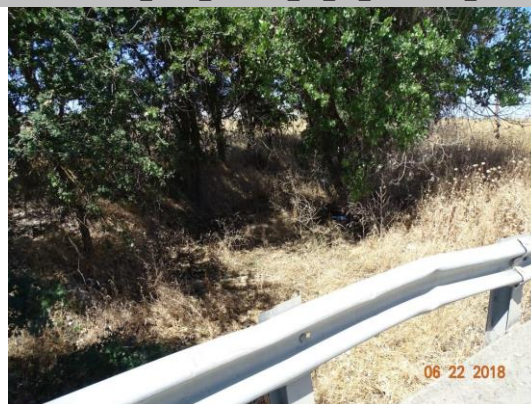
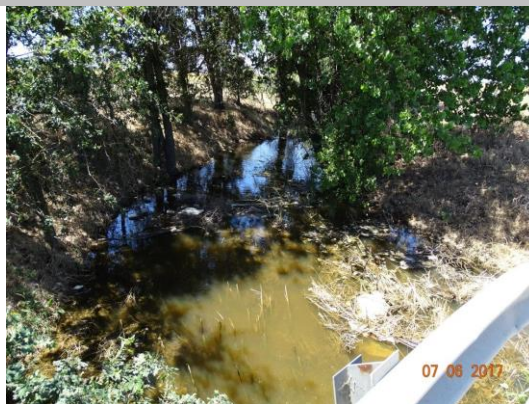
Photo 1 of 2 : CH_2018_NA0017_42_46_20180625_00066.jpg

Inspector Comments: Minimal vegetation does not impede the flow on the channel.

View of the downstream of the channel. Summer 2018

View of the downstream of the channel. Summer 2017

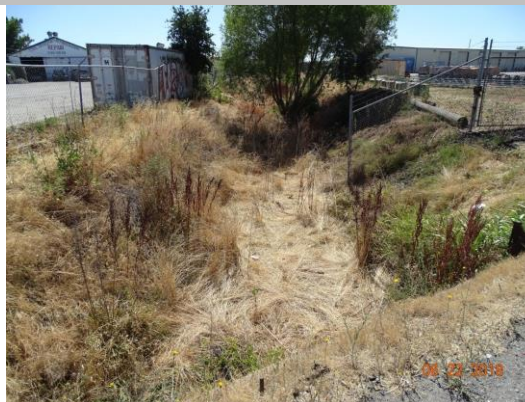
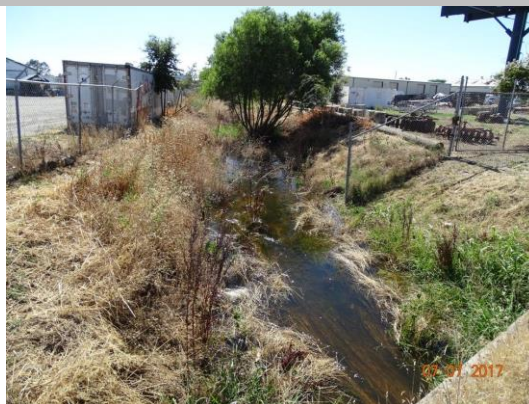
Photo 1 of 2 : CH_2018_NA0017_42_51_20180625_00064.jpg

Inspector Comments: Woody vegetation upstream from bridge should be removed to prevent impact to channel capacity.

View of the upstream of the channel. Summer 2018

Rating **	A	Issue No.	51 (cont)	GPS Lat/Long
Issue Type +	Ma	Location *		37.913239 °
Category	Rivers, Channels & Designated Flood			-121.225915 °
Item	Vegetation & Obstructions			
DWR ID	DWR_NA0017_42_c_2012_51			
Action/Comments				
Inspector Comments: Woody vegetation upstream from bridge should be removed to prevent impact to channel capacity.

View of the upstream of the channel. Summer 2017

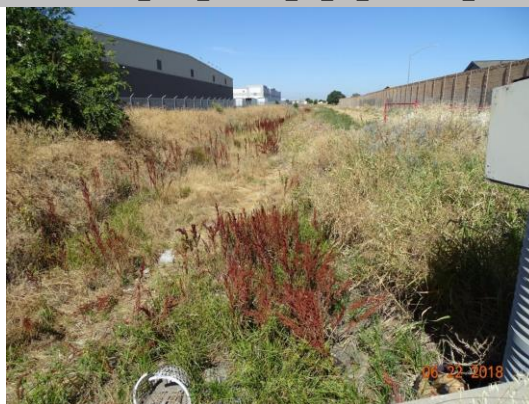
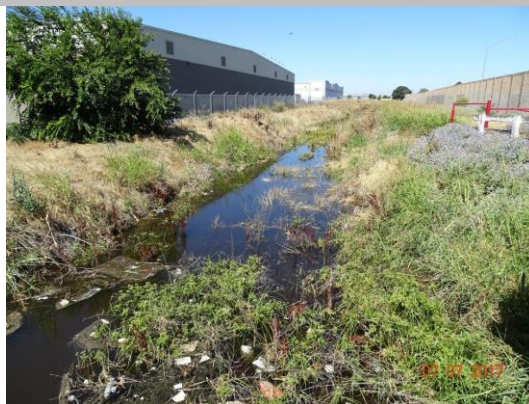
Photo 1 of 2 : CH_2018_NA0017_42_56_20180625_00063.jpg

Rating **	A	Issue No.	56	GPS Lat/Long
Issue Type +	Ma	Location *		37.913239 °
Category	Rivers, Channels & Designated Flood			-121.225915 °
Item	Vegetation & Obstructions			
DWR ID	DWR_NA0017_42_c_2012_56			
Action/Comments				
Inspector Comments: Minimal vegetation does not impede the flow on the channel.

View of the downstream end of the channel. Summer 2018

Rating **	A	Issue No.	56 (cont)	GPS Lat/Long
Issue Type +	Ma	Location *		37.913239 °
Category	Rivers, Channels & Designated Flood			-121.225915 °
Item	Vegetation & Obstructions			
DWR ID	DWR_NA0017_42_c_2012_56			
Action/Comments				
Inspector Comments: Minimal vegetation does not impede the flow on the channel.

View of the downstream end of the channel. Summer 2017

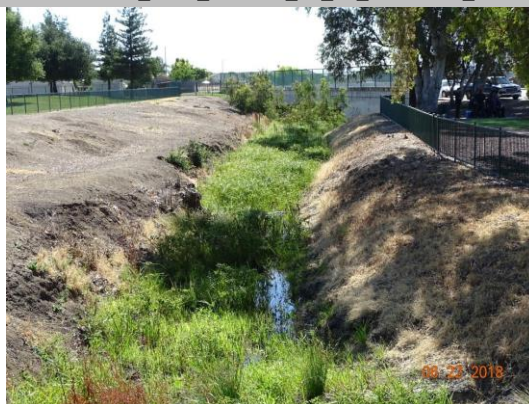
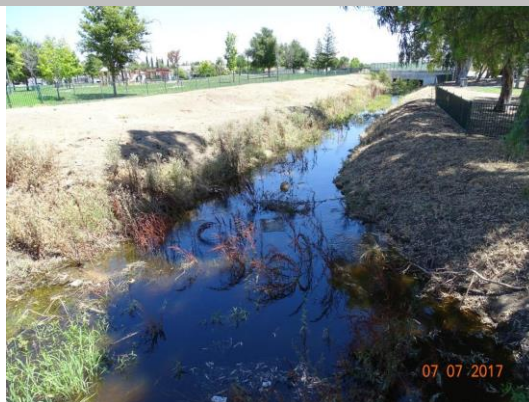
Photo 1 of 2 : CH_2018_NA0017_42_61_20180625_00061.jpg

Rating **	M	Issue No.	61	GPS Lat/Long
Issue Type +	Ma	Location *		37.914290 °
Category	Rivers, Channels & Designated Flood			-121.238800 °
Item	Vegetation & Obstructions			
DWR ID	DWR_NA0017_42_c_2012_61			
Action/Comments				
Inspector Comments: Woody vegetation upstream may impede the flow of the channel.

View of the channel looking upstream during 2018 inspection.

Inspector Comments: Woody vegetation upstream may impede the flow of the channel.

View of the channel looking upstream during 2017 inspection.

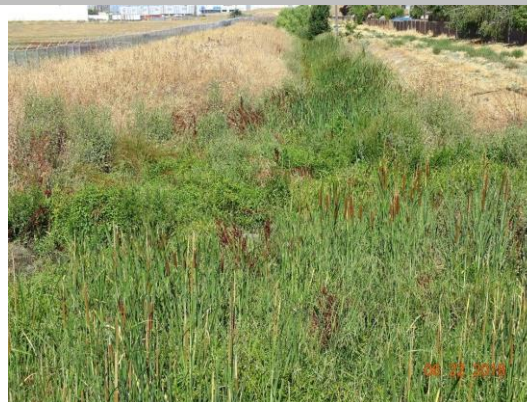
Photo 1 of 2 : CH_2018_NA0017_42_66_20180625_00062.jpg

Inspector Comments: Minimal vegetation may not impede the flow of the channel.

View of the channel looking downstream. Summer 2018

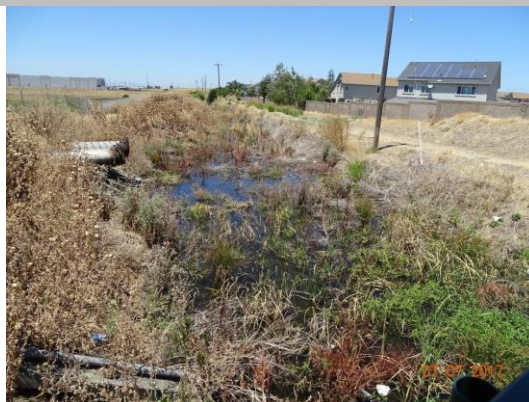
Photo 2 of 2 : CH_2018_NA0017_42_66_20180530_00027.jpg

Inspector Comments: Minimal vegetation may not impede the flow of the channel.

View of the channel looking downstream. Summer 2017

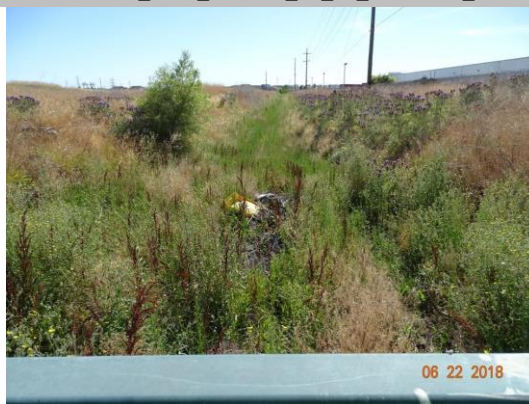
Photo 1 of 2 : CH_2018_NA0017_42_71_20180625_00059.jpg

Inspector Comments: Moderate vegetation was present in the channel but flow would likely not be impeded.

View of vegetation on the channel looking upstream. Summer 2018

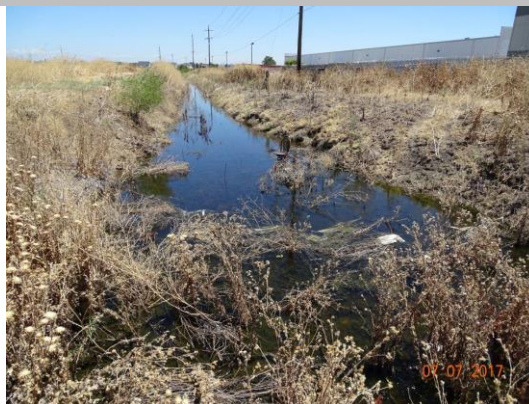
Photo 2 of 2 : CH_2018_NA0017_42_71_20180530_00030.jpg

Inspector Comments: Moderate vegetation was present in the channel but flow would likely not be impeded.

View of vegetation on the channel looking upstream. Summer 2017

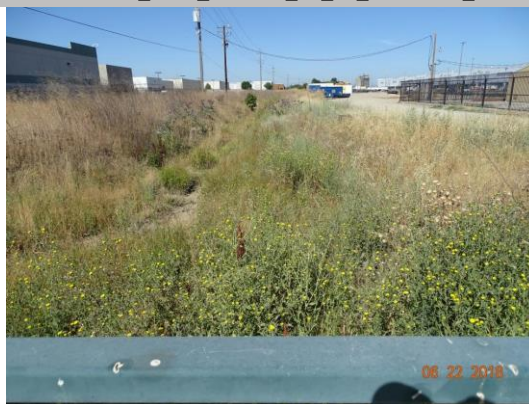
Photo 1 of 2 : CH_2018_NA0017_42_76_20180625_00060.jpg

Inspector Comments: Minimal vegetation on the channel may not impede the flow.

View of the vegetation looking downstream during 2018 inspection.

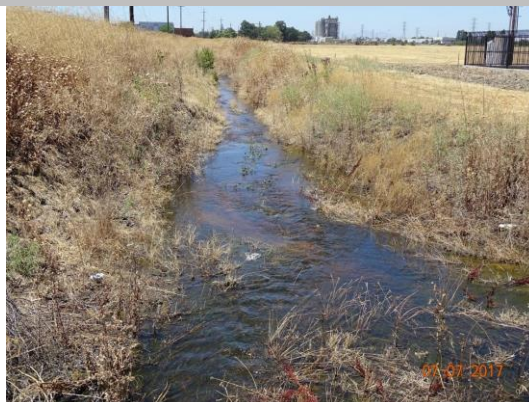
Photo 2 of 2 : CH_2018_NA0017_42_76_20180530_00032.jpg

Inspector Comments: Minimal vegetation on the channel may not impede the flow.

View of the vegetation looking downstream during 2017 inspection.

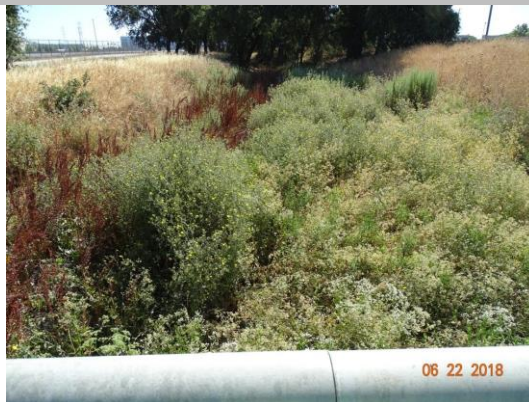
Photo 1 of 2 : CH_2018_NA0017_42_81_20180625_00057.jpg

Inspector Comments: Moderate vegetation present in channel may impede the flow.

View of the vegetation on the channel looking upstream. Summer 2018

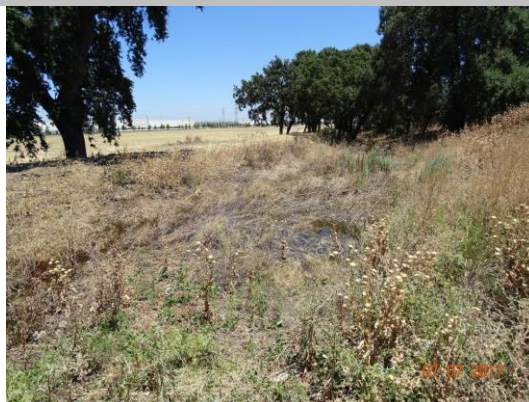
Photo 2 of 2 : CH_2018_NA0017_42_81_20180530_00035.jpg

Rating **	M	Issue No.	81 (cont)	GPS Lat/Long
Issue Type +	Ma	Location *		37.912070 °
Category	Rivers, Channels & Designated Flood			-121.258811 °
Item	Vegetation & Obstructions			
DWR ID	DWR_NA0017_42_c_2012_81			
Action/Comments				
Inspector Comments: Moderate vegetation present in channel may impede the flow.

View of the vegetation on the channel looking upstream.

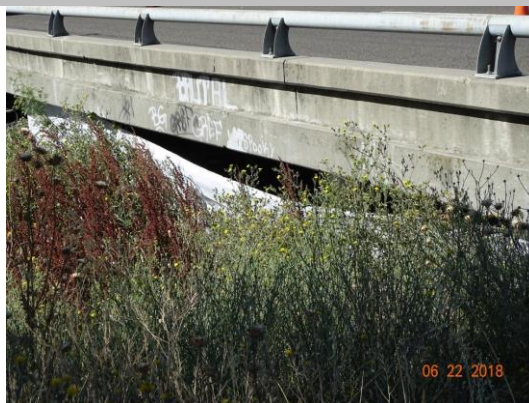
Photo 1 of 1 : CH_2018_NA0017_42_85_20180702_00078.jpg

Rating **	U	Issue No.	85	GPS Lat/Long
Issue Type +	Ma	Location *		37.912070 °
Category	Rivers, Channels & Designated Flood			-121.258811 °
Item	Encroachments			
DWR ID	DWR_NA0017_42_c_2012_85			
Action/Comments				
Inspector Comments: Individuals have erected a barrier from the overcrossing to the ground to provide shelter. Unable to determine how the tarp was anchored.

View of encroachment on upstream side of channel, 2018.

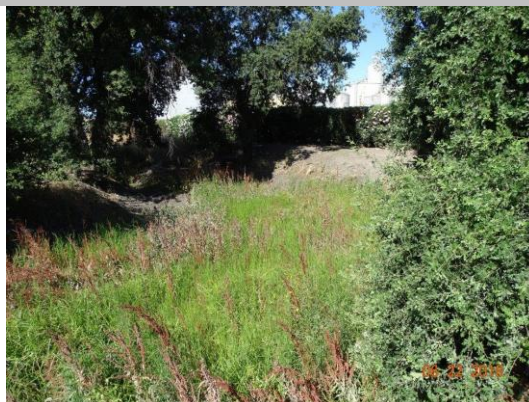
Photo 1 of 2 : CH_2018_NA0017_42_86_20180625_00058.jpg

Inspector Comments: Moderate woody vegetation may impede the flow of the channel.

View of the channel looking downstream. Summer 2018

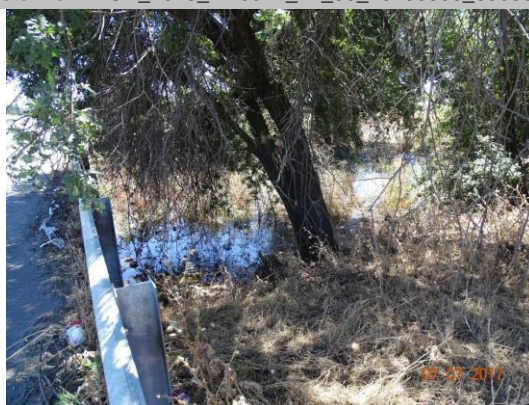
Photo 2 of 2 : CH_2018_NA0017_42_86_20180530_00036.jpg

View of the channel looking downstream. Summer 2017

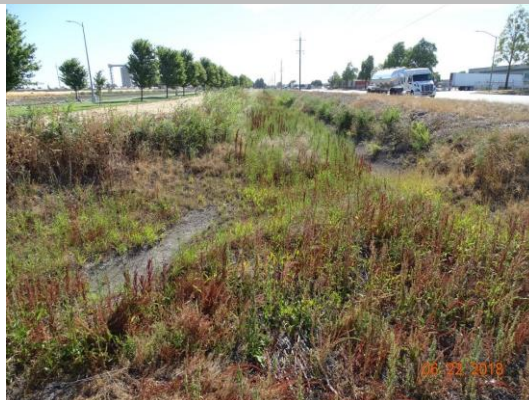
Photo 1 of 2 : CH_2018_NA0017_42_91_20180625_00055.jpg

View of the channel looking upstream during 2018 inspection.

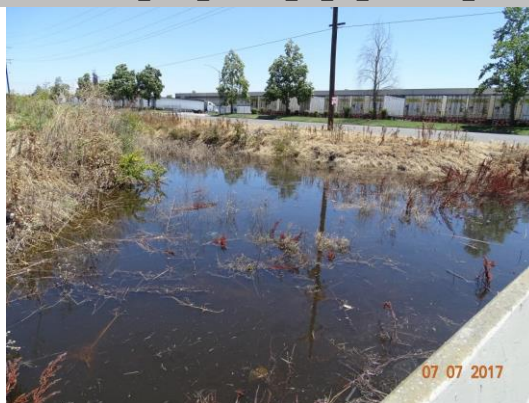
Photo 2 of 2 : CH_2018_NA0017_42_91_20180530_00038.jpg

View of the channel looking upstream during 2017 inspection.

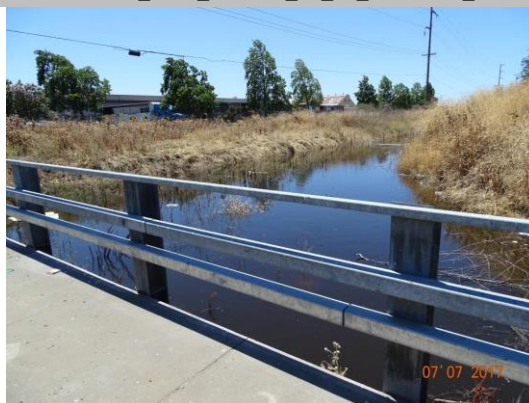
Photo 2 of 2 : CH_2018_NA0017_42_96_20180530_00040.jpg

Rating **	A	Issue No.	96	GPS Lat/Long
Issue Type +	Ma	Location *		37.908433 °
Category	Rivers, Channels & Designated Flood			-121.269214 °
Item	Vegetation & Obstructions			
DWR ID	DWR_NA0017_42_c_2012_96			
Action/Comments				
Inspector Comments: Minimal vegetation was found, but the flow is not impeded.

View of the channel looking downstream. Summer 2017

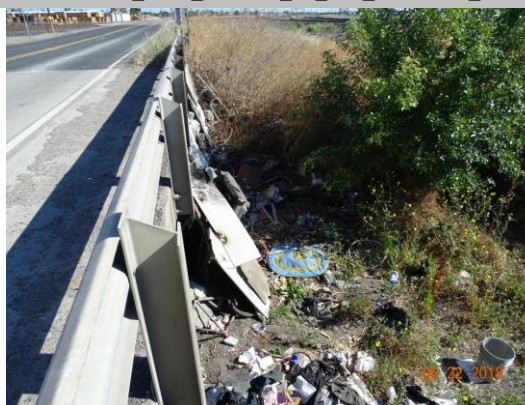
Photo 1 of 1 : CH_2018_NA0017_42_105_20180625_00052.jpg

Inspector Comments: Trash and debris are present in the channel.

View of debris on the upstream end of the channel. Summer 2018

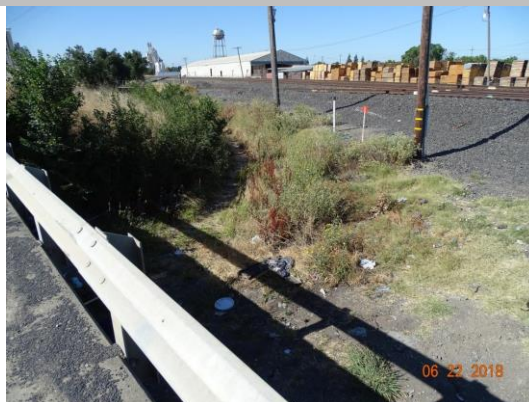
Photo 1 of 2 : CH_2018_NA0017_42_106_20180625_00053.jpg

Inspector Comments: Vegetation and debris may impede the flow of the channel.

View of the channel looking downstream during 2018 inspection.

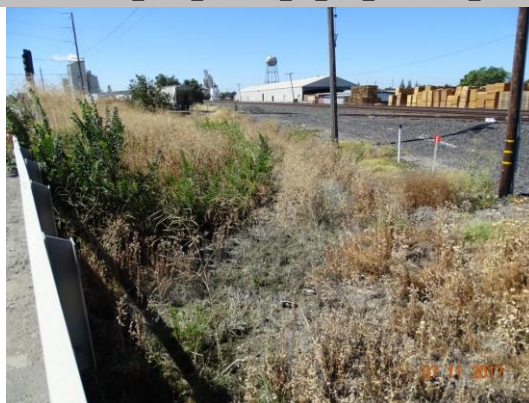
Photo 2 of 2 : CH_2018_NA0017_42_106_20180530_00046.jpg

View of the channel looking downstream during 2017 inspection.

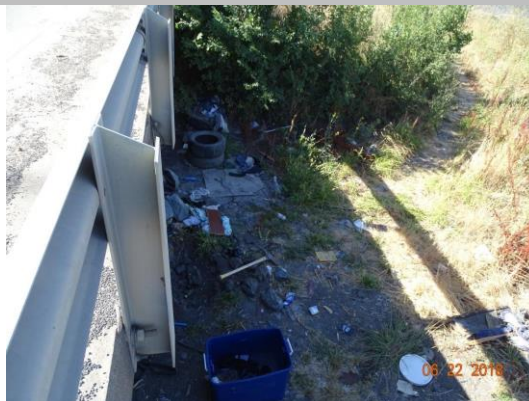
Photo 1 of 1 : CH_2018_NA0017_42_110_20180625_00054.jpg

Inspector Comments: Trash or debris are present in the channel.

View of debris on the downstream end of the channel. Summer 2018

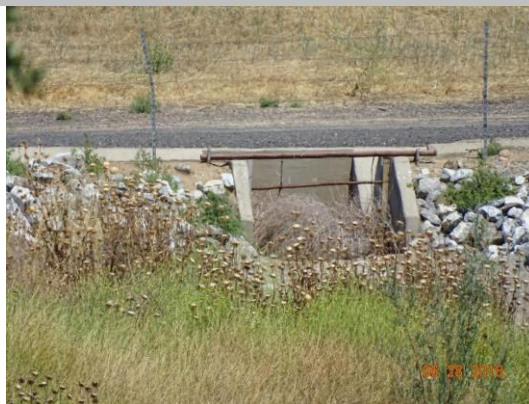
Photo 1 of 1 : CH_2018_NA0017_44_119_20180703_00089.jpg

Rating **	A	Issue No.	119	GPS Lat/Long
Issue Type +	Ma	Location *		37.900580 °
Category	Rivers, Channels & Designated Flood			-120.936018 °
Item	Gates			
DWR ID	DWR_NA0017_44_c_2014_119			
Action/Comments				
Inspector Comments: The gate appears to be functional.

View of the release gate from Farmington Dam looking upstream of the creek. Summer 2018

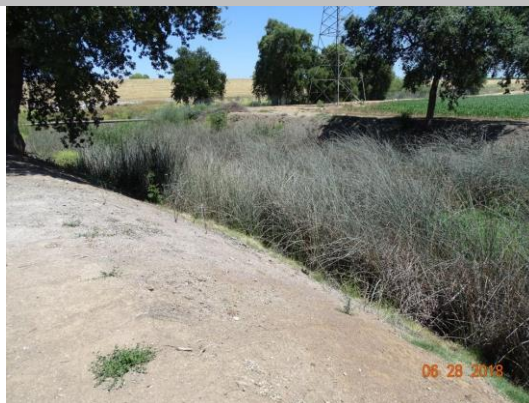
Photo 1 of 1 : CH_2018_NA0017_44_6_20180703_00090.jpg

Rating **	M	Issue No.	6	GPS Lat/Long
Issue Type +	Ma	Location *		37.914340 °
Category	Rivers, Channels & Designated Flood			-120.937860 °
Item	Vegetation & Obstructions			
DWR ID	DWR_NA0017_44_c_2012_6			
Action/Comments				
Inspector Comments: Vegetation in the channel may impede the flow.

View of the vegetation on the channel. Summer 2018

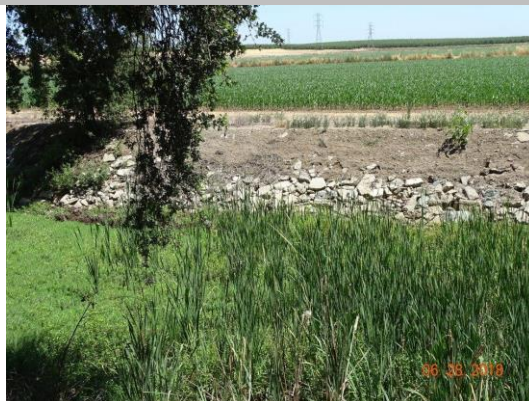
Photo 1 of 1 : CH_2018_NA0017_44_9_20180703_00091.jpg

Inspector Comments: Existing riprap appeared to be maintained.

View of the existing revetments looking downstream during 2018 inspection.

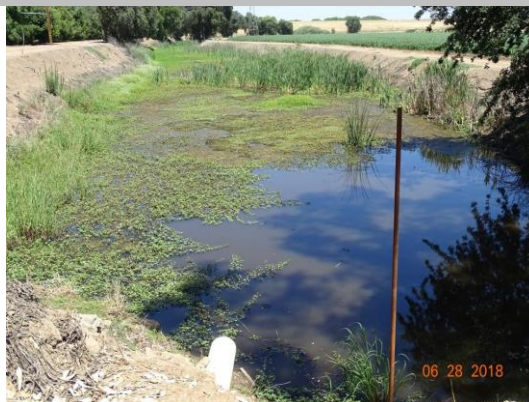
Photo 1 of 1 : CH_2018_NA0017_44_99_20180703_00086.jpg

Check Point / View				
Wedding Chappel Crossing / Up				
Rating **	A	Issue No.	99	GPS Lat/Long
Issue Type +	Ma	Location *		37.900040 °
Category	Rivers, Channels & Designated Flood			-120.938949 °
Item	Vegetation & Obstructions			
DWR ID	DWR_NA0017_42_c_2013_99			
Action/Comments				
Inspector Comments: Minimal vegetation not likely to impede the flow in the gate downstream.

View of the vegetation on the channel looking upstream. Summer 2018

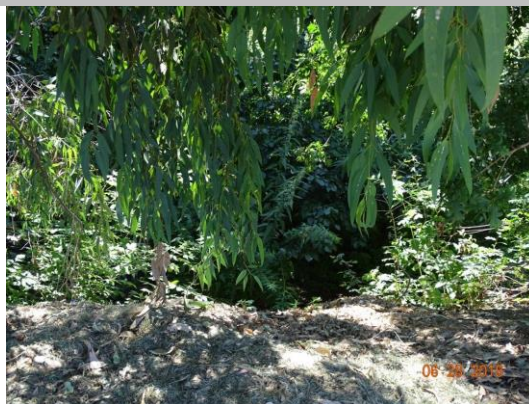
Photo 1 of 1 : CH_2018_NA0017_44_104_20180703_00088.jpg

Inspector Comments: Heavy vegetation growth will impede the flow and may block approximately 50% capacity of the channel.

View of the vegetation on the downstream of the channel during 2018 inspection.

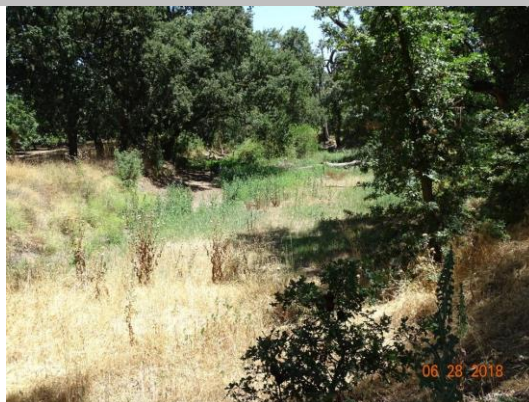
Photo 1 of 2 : CH_2018_NA0017_44_141_20180703_00084.jpg

Rating **	M	Issue No.	141	GPS Lat/Long
Issue Type +	Ma	Location *		37.903161 °
Category	Rivers, Channels & Designated Flood			-120.945289 °
Item	Vegetation & Obstructions			
DWR ID	DWR_NA0017_44_c_2015_141			
Action/Comments				
Inspector Comments: Vegetation and logs were present that may impede the flow of the channel.

Wood trunks and vegetation may impede the flow of the channel.
Summer 2018

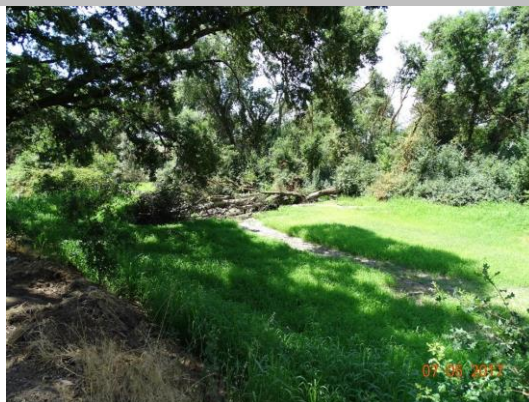
Photo 2 of 2 : CH_2018_NA0017_44_141_20180530_00057.jpg

Wood trunks and vegetation may impede the flow of the channel.
Summer 2017

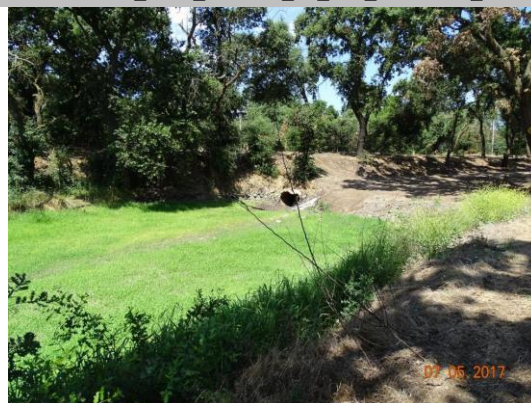
Photo 1 of 1 : CH_2018_NA0017_44_150_20180530_00061.jpg

Rating **	A	Issue No.	150	GPS Lat/Long
Issue Type +	Ma	Location *		37.903161 °
Category	Rivers, Channels & Designated Flood			-120.945289 °
Item	Gates			
DWR ID	DWR_NA0017_44_c_2015_150			
Action/Comments				
Inspector Comments: The pipe appears to be free of debris and does not appear to impede the flow of the channel.

View of the pipe looking upstream from the channel during 2017 inspection.

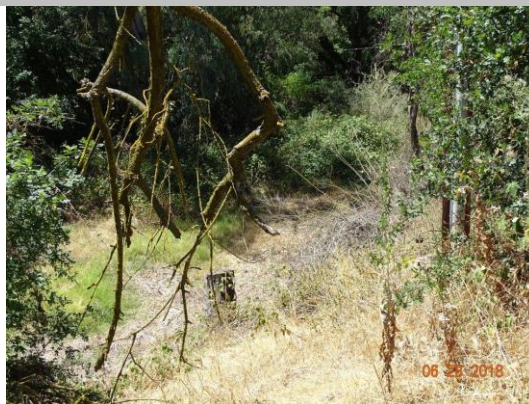
Photo 1 of 1 : CH_2018_NA0017_44_146_20180703_00085.jpg

Rating **	M	Issue No.	146	GPS Lat/Long
Issue Type +	Ma	Location *		37.903161 °
Category	Rivers, Channels & Designated Flood			-120.945289 °
Item	Vegetation & Obstructions			
DWR ID	DWR_NA0017_44_c_2015_146			
Action/Comments				
Inspector Comments: Vegetation growth may impede the flow of the channel.

View of the vegetation on the downstream of the channel. Summer 2018

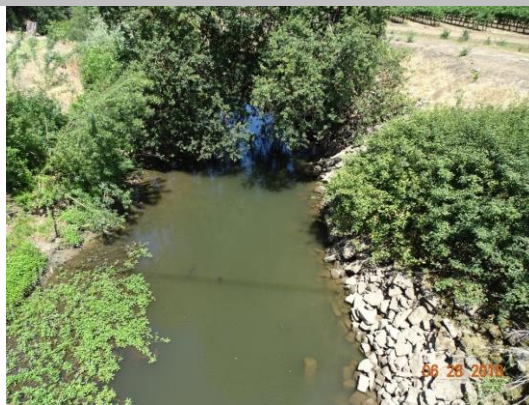
Photo 1 of 1 : CH_2018_NA0017_44_21_20180703_00092.jpg

Inspector Comments: Minimal vegetation but not likely to impede the flow of the channel.

View of the channel looking upstream during 2018 inspection.

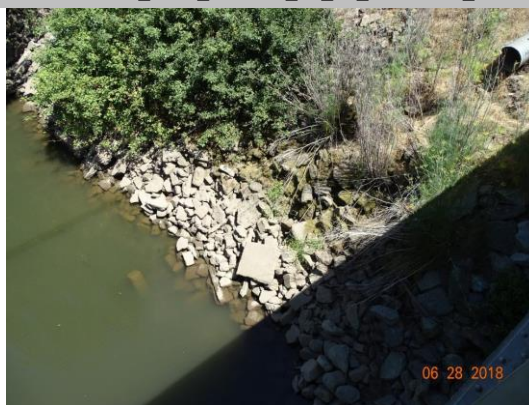
Photo 1 of 1 : CH_2018_NA0017_44_24_20180703_00093.jpg

Inspector Comments: Existing riprap is properly maintained.

Existing revetments left bank. Summer 2018

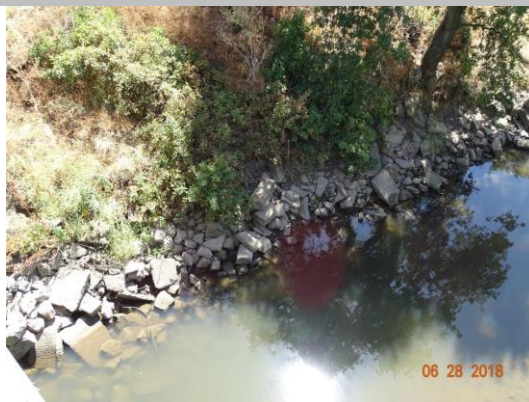
Photo 1 of 1 : CH_2018_NA0017_44_29_20180703_00095.jpg

Rating **	A	Issue No.	29	GPS Lat/Long
Issue Type +	Ma	Location *		37.925330 °
Category	Rivers, Channels & Designated Flood			-121.000120 °
Item	Revetments			
DWR ID	DWR_NA0017_44_c_2012_29			
Action/Comments				
Inspector Comments: Existing riprap is properly maintained.

View of the revetments on the left bank of the channel looking downstream during 2018 inspection.

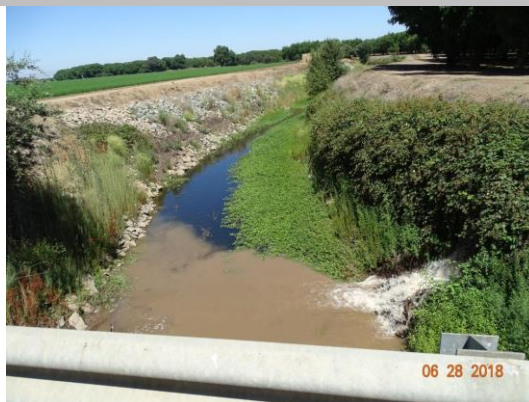
Photo 1 of 1 : CH_2018_NA0017_44_31_20180703_00096.jpg

Inspector Comments: Minimal vegetation that will not impede flow.

View of the channel looking upstream during 2018 inspection.

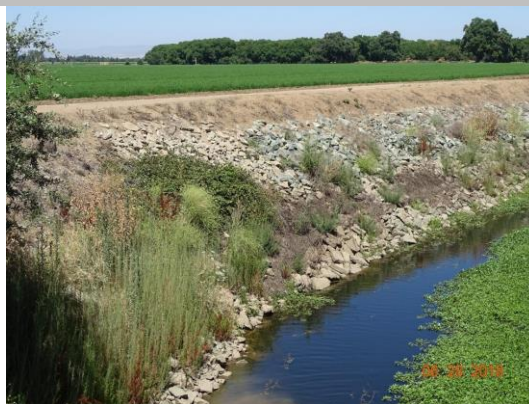
Photo 1 of 1 : CH_2018_NA0017_44_34_20180703_00097.jpg

Inspector Comments: Existing revetments were maintained properly on the channel bank. LMA has placed additional riprap under the bridge.

View of the existing revetments on the right channel bank looking upstream. Summer 2018

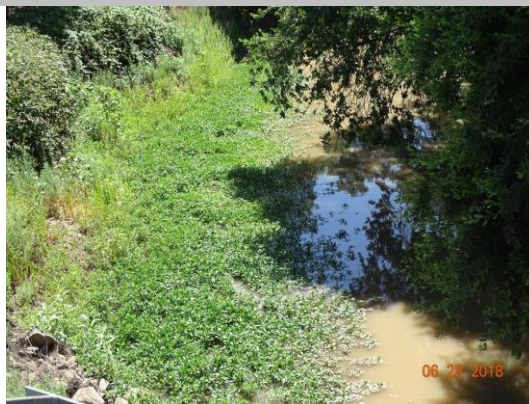
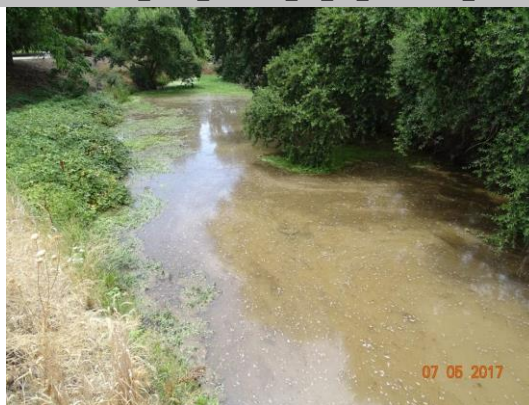
Rating **	A	Issue No.	36	GPS Lat/Long
Issue Type +	Ma	Location *		37.920060 °
Category	Rivers, Channels & Designated Flood			-121.027790 °
Item	Vegetation & Obstructions			
DWR ID	DWR_NA0017_44_c_2012_36			
Action/Comments				
Inspector Comments: Minimal vegetation that will not impede flow.

View of the downstream of the channel. Summer 2018

View of the downstream of the channel. Summer 2017

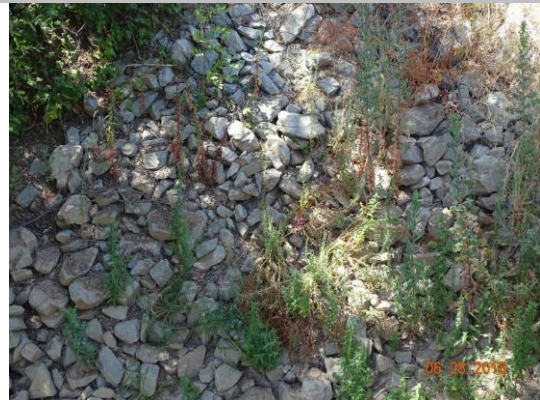
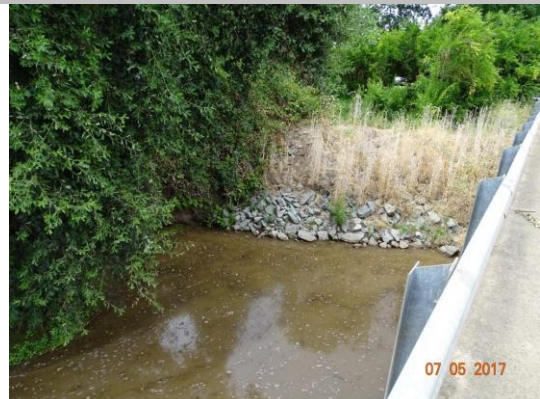
Rating **	A	Issue No.	39	GPS Lat/Long
Issue Type +	Ma	Location *		37.920060 °
Category	Rivers, Channels & Designated Flood			-121.027790 °
Item	Revetments			
DWR ID	DWR_NA0017_44_c_2012_39			
Action/Comments				
Inspector Comments: Existing riprap protection is properly maintained.

View of the revetments on the right bank of the channel. Summer 2018

View of the revetments on the right bank of the channel.

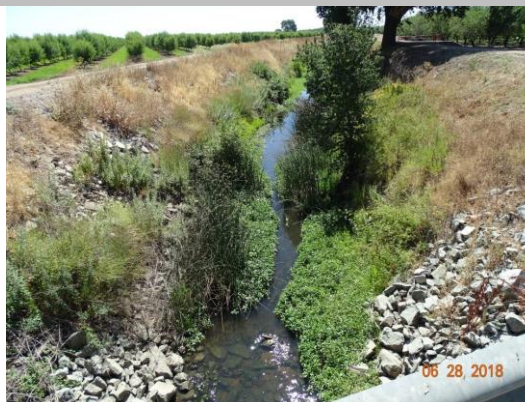
Inspector Comments: Minimal vegetation that will not impede flow.

View of the channel looking upstream. Summer 2018

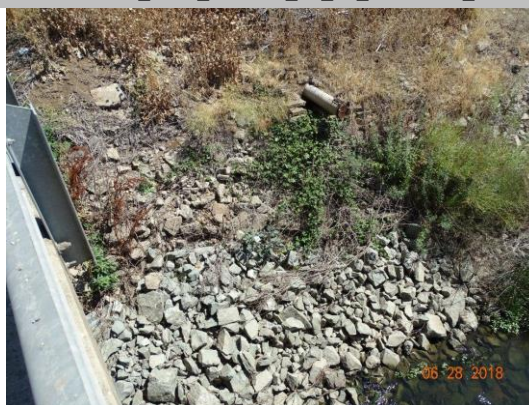
Inspector Comments: LMA has placed new revetments on the banks of the channel. Permit #19000. Existing revetments are properly maintained.

View of the revetment on the right bank of the channel looking upstream.
Summer 2018

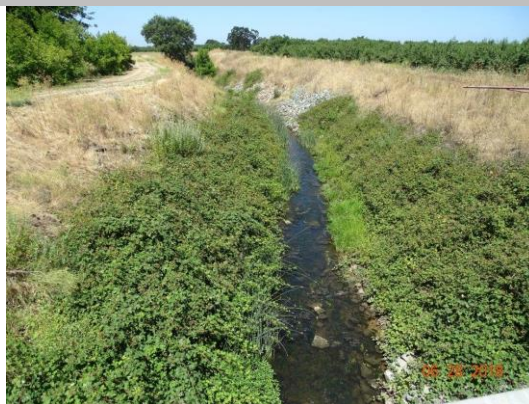
Inspector Comments: The vegetation growth around the channel is not impeding the flow.

View of the channel looking downstream. Summer 2018

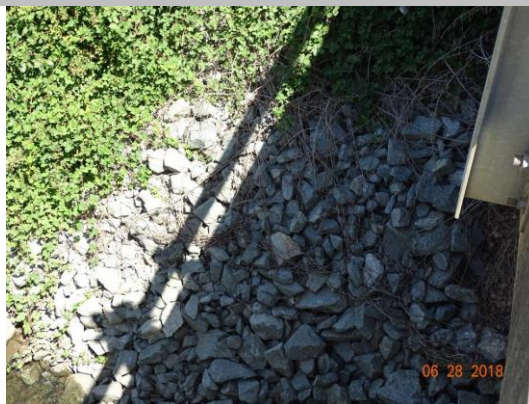
Inspector Comments: Existing riprap protection is properly maintained. LMA has placed more revetments on both banks of the channel. Permit #19000

View of the existing revetment looking downstream. Summer 2018

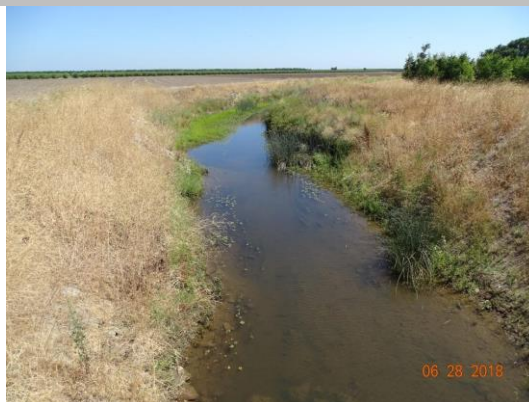
Inspector Comments: Minimal vegetation was present on the channel, but it may not impede the flow of the channel.

View of the upstream of the channel. Summer 2018

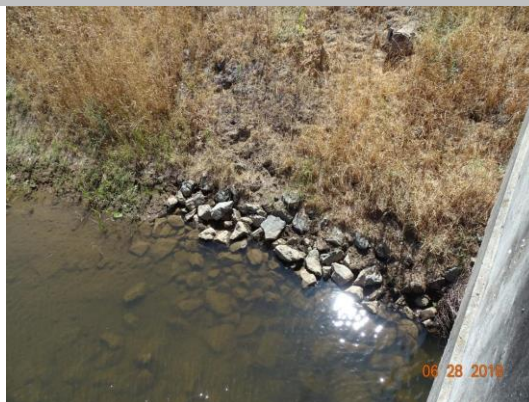
Inspector Comments: Existing revetments are properly maintained.

View of the revetments on the upstream of the channel. Summer 2018

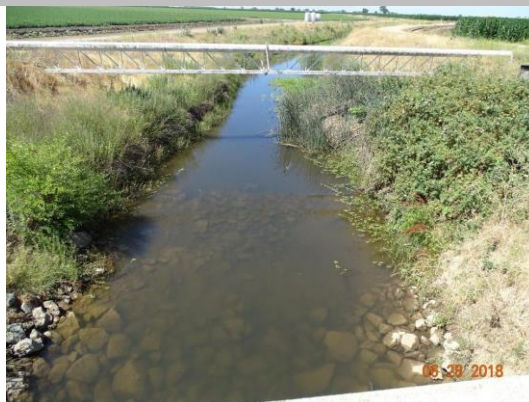
Rating **	A	Issue No.	56	GPS Lat/Long
Issue Type +	Ma	Location *		37.895050 °
Category	Rivers, Channels & Designated Flood			-121.118200 °
Item	Vegetation & Obstructions			
DWR ID	DWR_NA0017_44_c_2012_56			
Action/Comments				
Inspector Comments: Minimal vegetation was present on the channel, but it may not impede the flow of the channel.

View of the channel looking downstream. Summer 2018

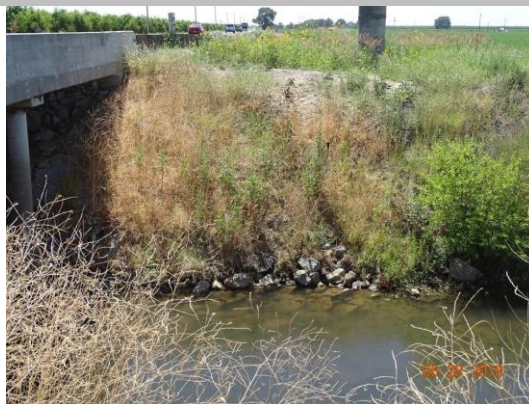
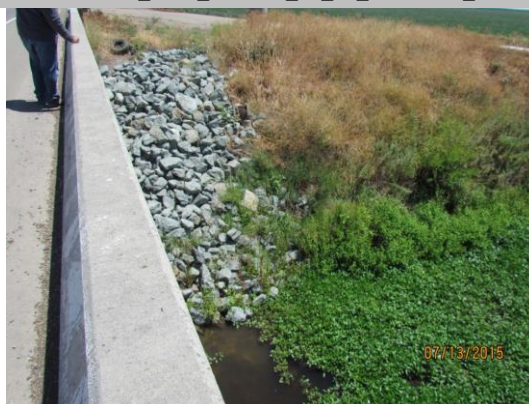
Rating **	M	Issue No.	59	GPS Lat/Long
Issue Type +	Ma	Location *		37.895050 °
Category	Rivers, Channels & Designated Flood			-121.118200 °
Item	Revetments			
DWR ID	DWR_NA0017_44_c_2012_59			
Action/Comments				
Inspector Comments: Existing revetments have vegetation that requires maintenance.

View of existing revetments on the channel banks looking downstream.
Summer 2018

View of existing revetments on the channel banks looking downstream.

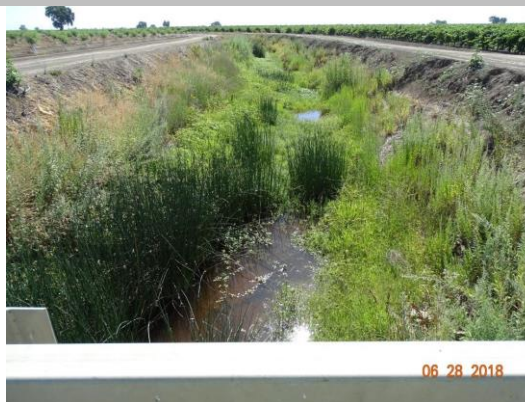
Inspector Comments: Minimal vegetation was present in the channel but flow may not be impeded..

View of the vegetation on the upstream of the channel. Summer 2018

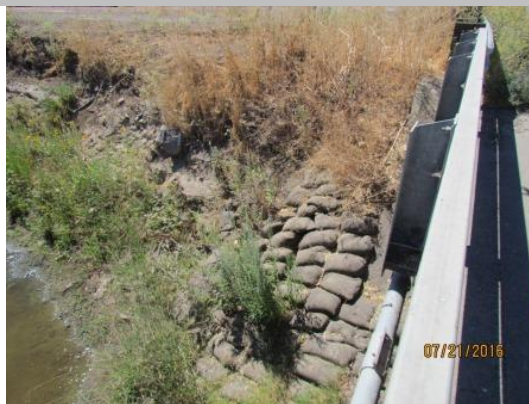
Inspector Comments: Existing riprap protection has minimal vegetation but appears properly maintained.

View of existing riprap on the upstream of the channel.

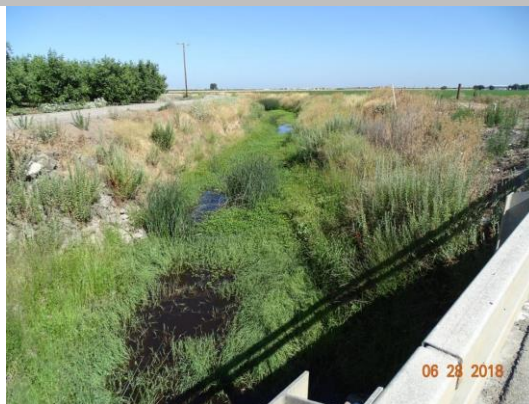
Rating **	A	Issue No.	66	GPS Lat/Long
Issue Type +	Ma	Location *		37.880726 °
Category	Rivers, Channels & Designated Flood			-121.146929 °
Item	Vegetation & Obstructions			
DWR ID	DWR_NA0017_44_c_2012_66			
Action/Comments				
Inspector Comments: Minimal vegetation was present in the channel but flow may not be impeded..

View of the channel looking downstream. Summer 2018

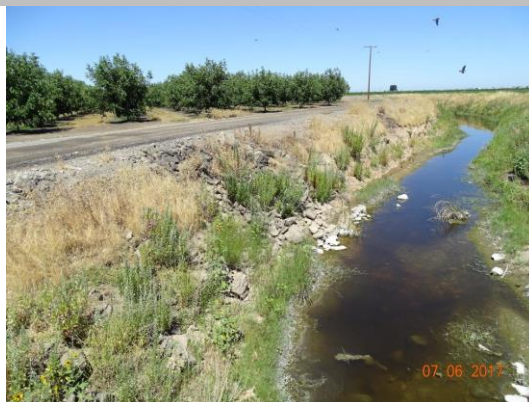
Inspector Comments: Existing riprap protection has minimal vegetation but appears properly maintained.

View of the existing riprap on the channel bank looking downstream.

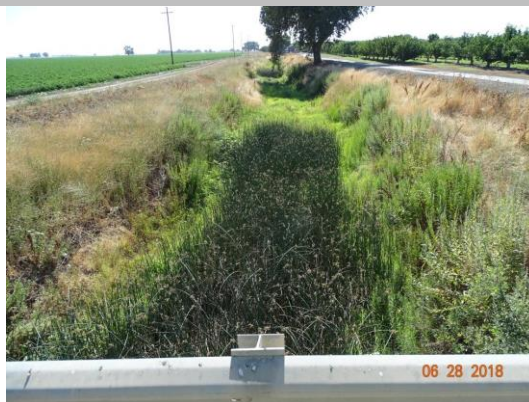
Inspector Comments: Minimal vegetation is present in the channel, but the flow is not impeded.

View of vegetation on the upstream side of the channel. Summer 2018
